Alpine Naturgefahren und Herausforderungen für alpine Infrastruktur in der Zukunft

Michael Krautblatter

**Fachgebiet Hangbewegungen
Ingenieur fakultät Bau Geo Umwelt
Technische Universität München**

Rock slope failure in permafrost rock walls

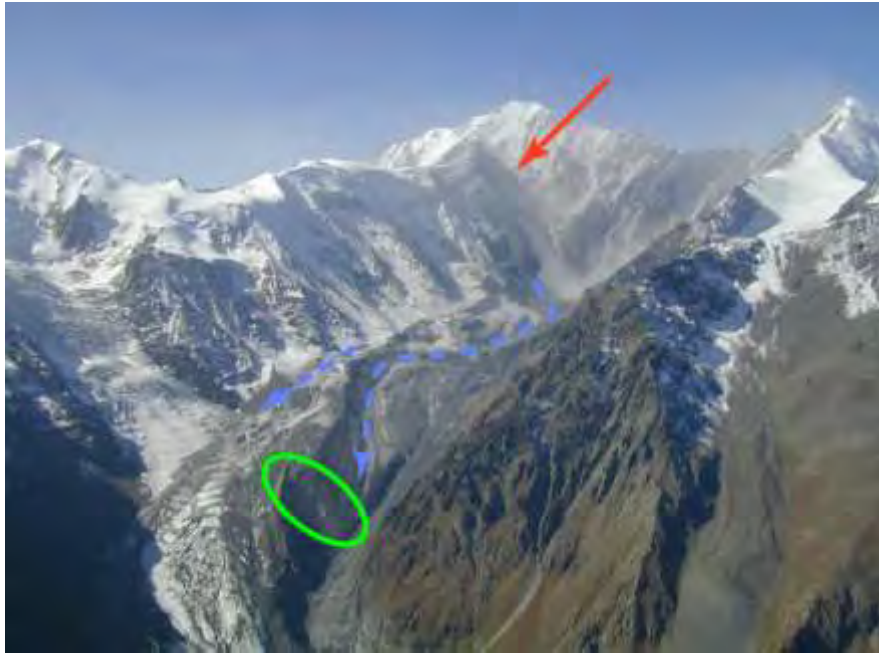
*Kolka-Karmadon rock-/ice avalanche
(Russ. Caucasus 2002, 100 mio. m³)*

140 casualties

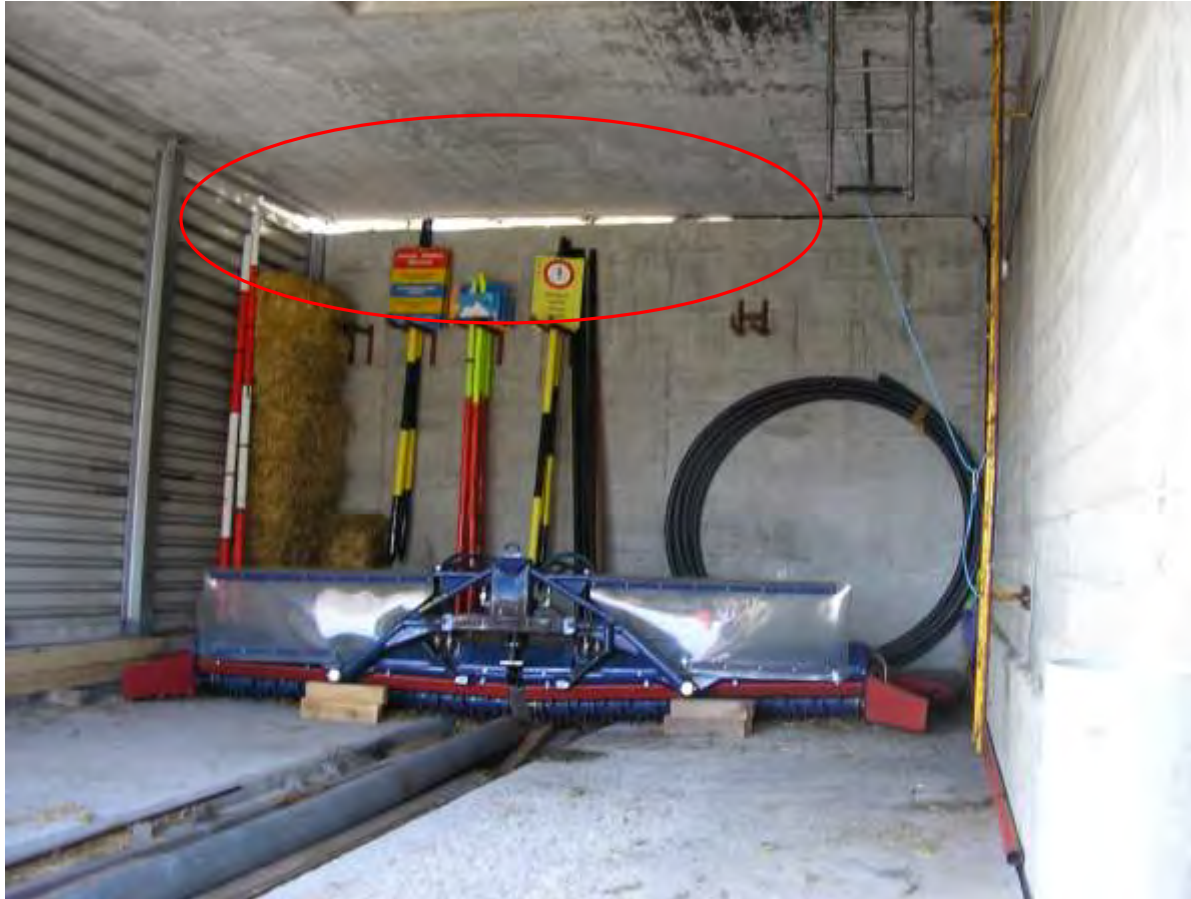
*Deformation Gipfelseilbahn
(Gemsstock, Andermatt, CH)*

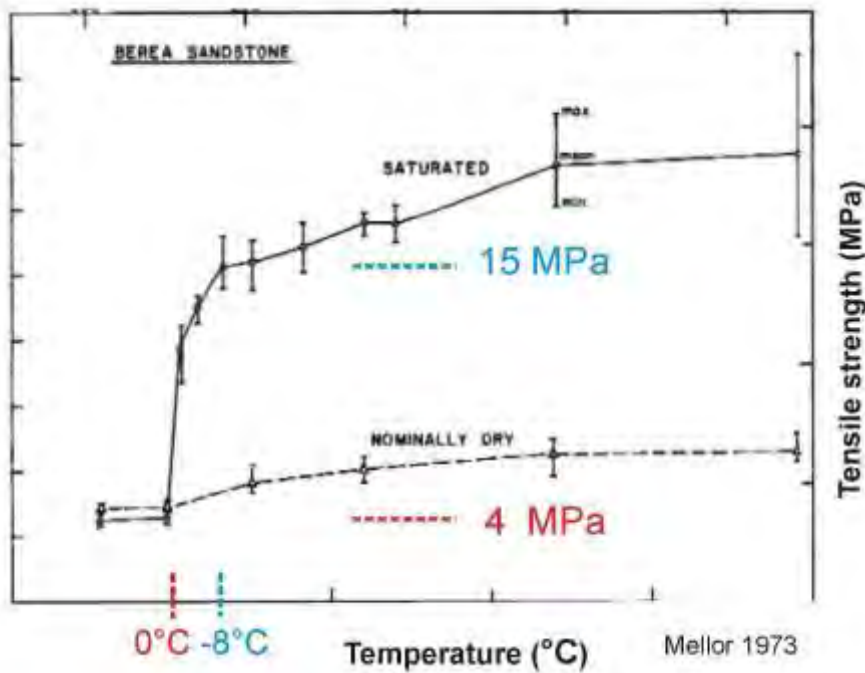
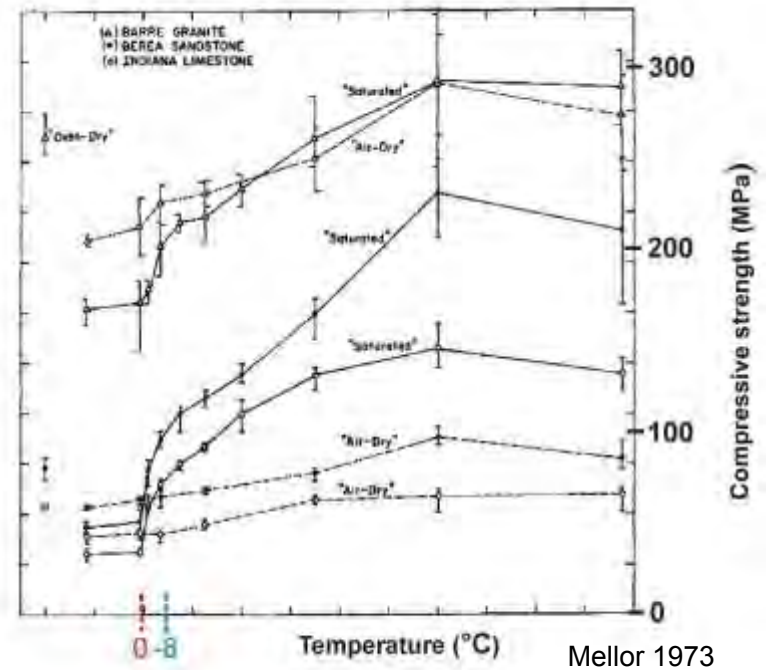
Compressive and tensile rock strength during thaw

- Compressive and tensile strength of saturated intact rock decrease by 25-75% when thawing (Mellor 1973).

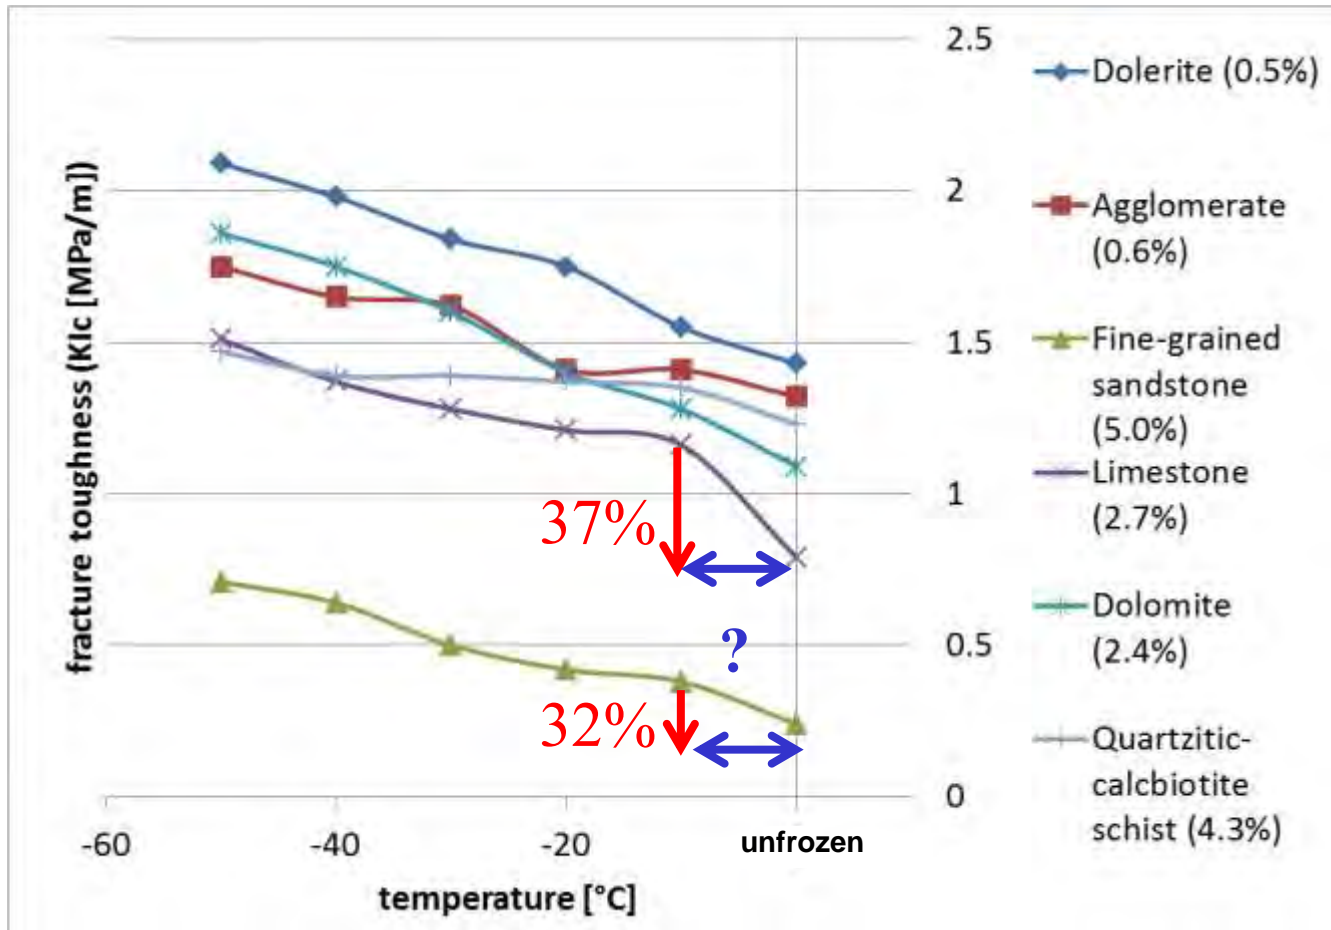
Fracture toughness during thaw

- Fracture toughness in water-saturated rocks decreases by up to 40% when thawing (Dwivedi et al. 2000)
- This effect is more pronounced for repeated freezing (Inada&Yokota 1984)

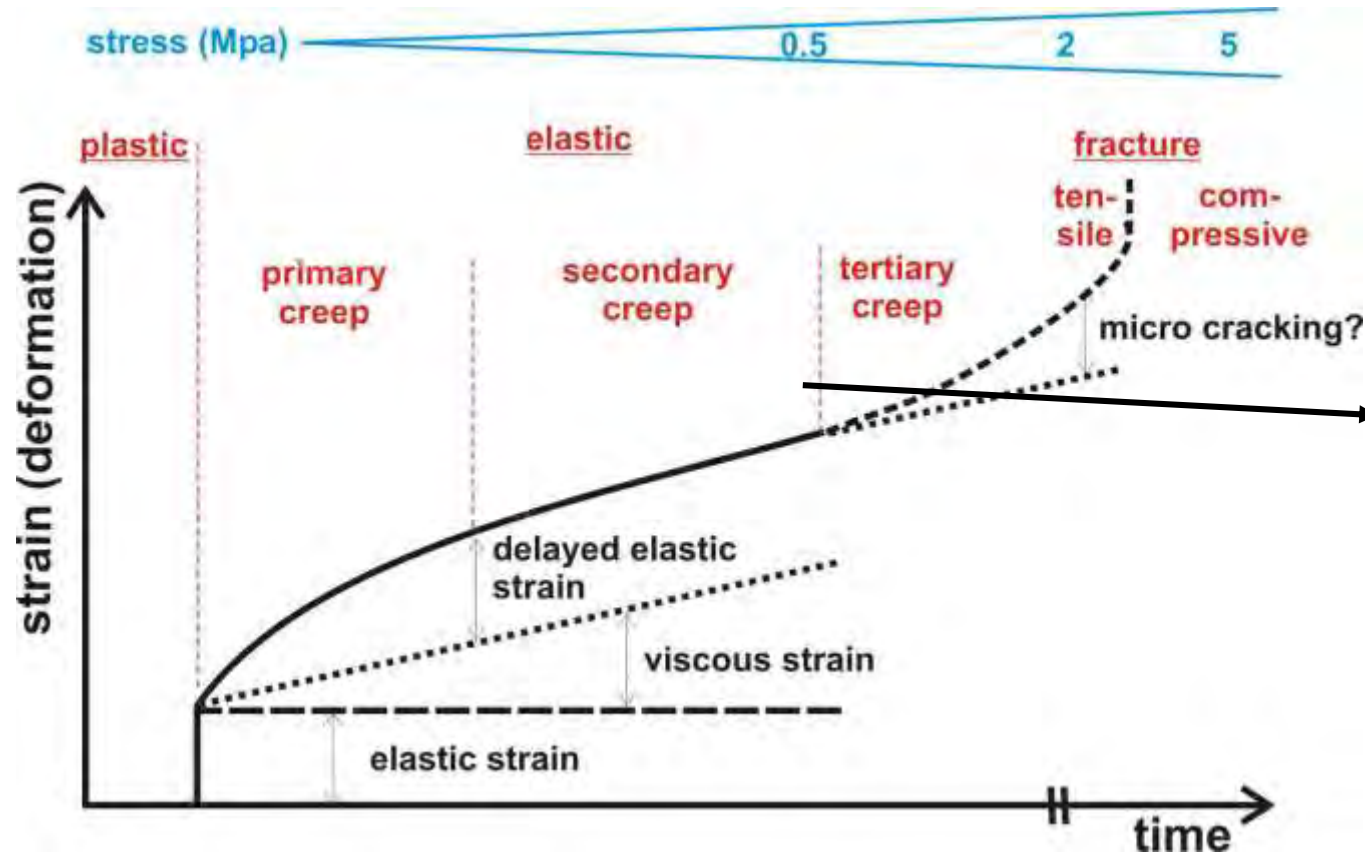
Shear resistance of ice itself

$$\tau_{xy}^n = \dot{\epsilon}_{xy} / A$$

- At very low velocity (i.e. strain rate), at which e.g. subcritical cracking of rock bridges occurs, the shear resistance of ice due to creep is negligible.
- Fracturing only occurs at higher velocities (strain rate $>10^{-3} \text{ s}^{-1}$; Sanderson, 1988).

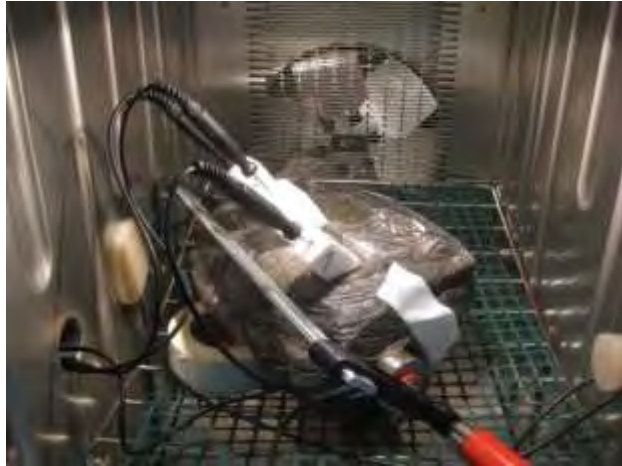
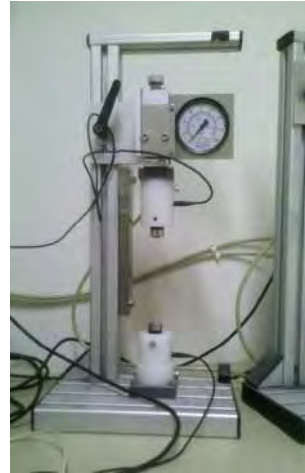
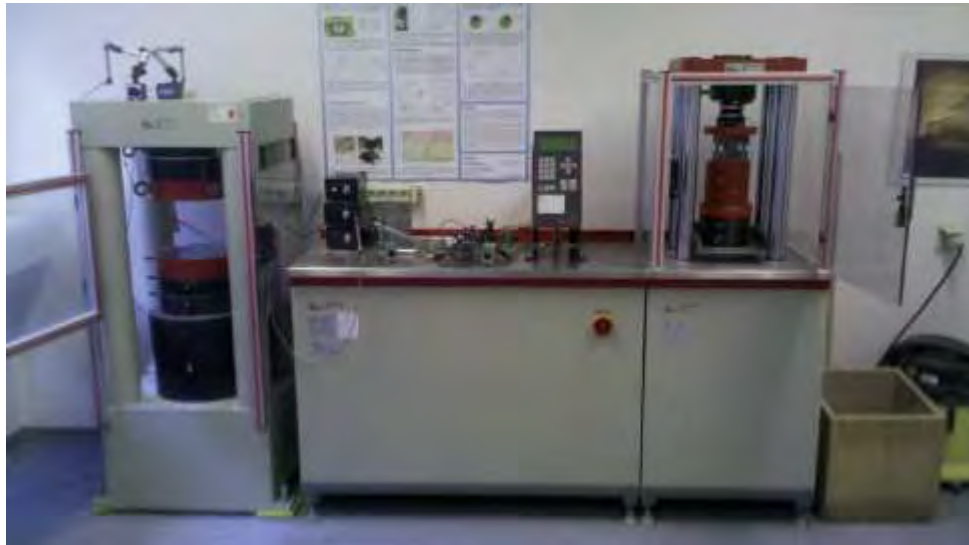
Non-destructive and destructive testing techniques

- P- wave velocity
- S-wave velocity
- >Elastic moduli

- Compressive strength (Uniaxial)
- Tensile strength (Brazilian)

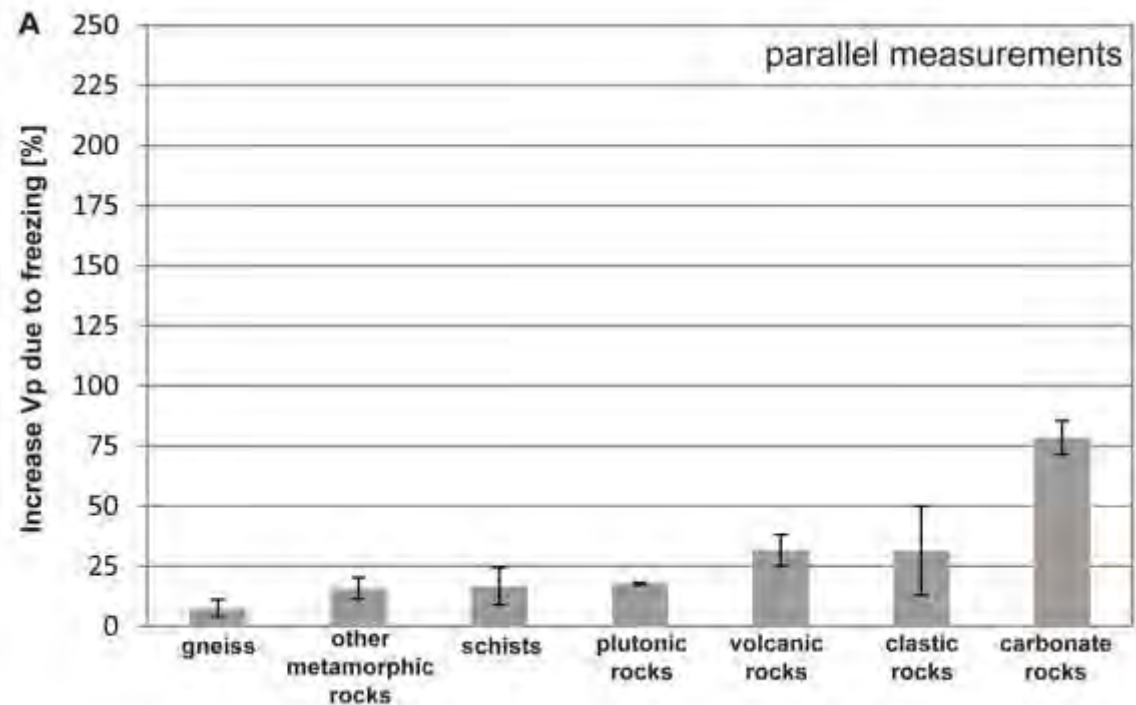
Increase in fracture toughness: P-Wave velocity as a proxy

P-wave velocity is the best correlated factor with K_{Ic} fracture toughness (Chang et al. 2002, $R^2=0.8$).

P-wave velocity can be measured non-destructively and in different directions.

High-resolution (0.2°C increments) changes in P-wave velocity were measured in 22 alpine and arctic rock samples (Dräbing & Krautblatter, 2012, *The Cryosphere*)

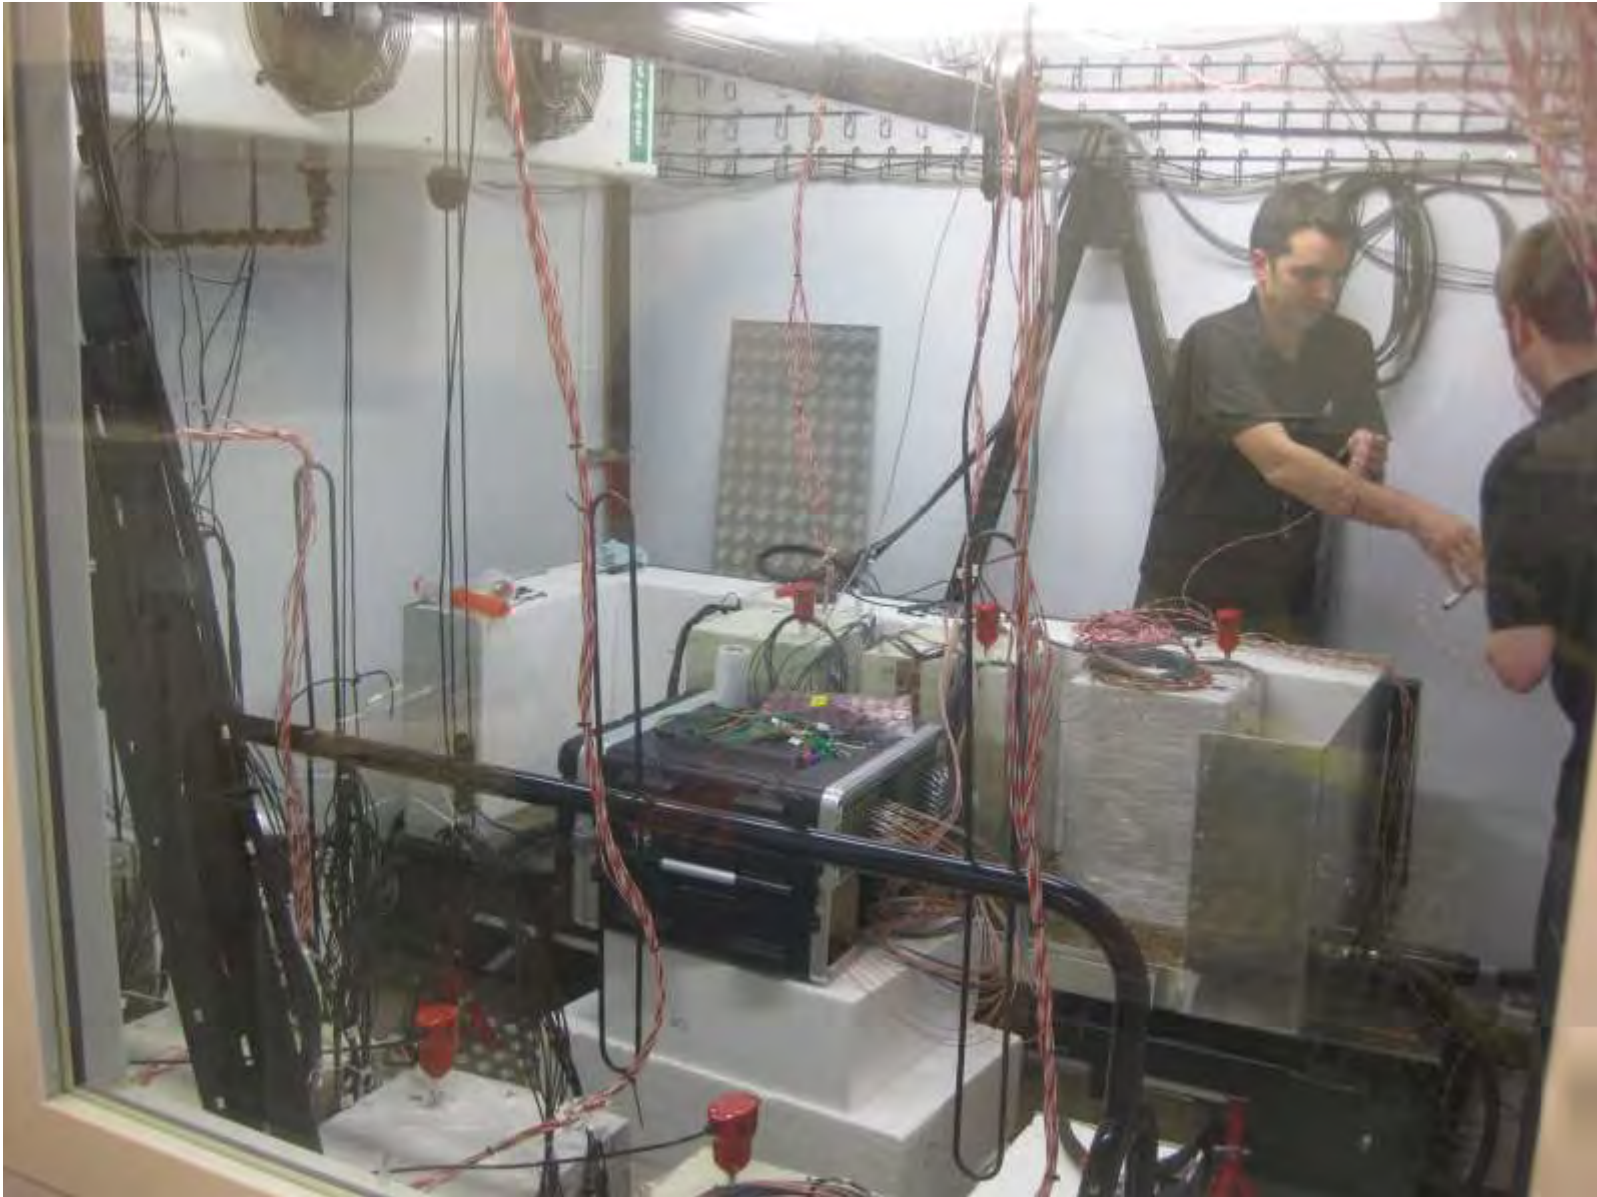
Experimental setup: 4 soft chalk blocks, 2 Wetterstein limestone blocks

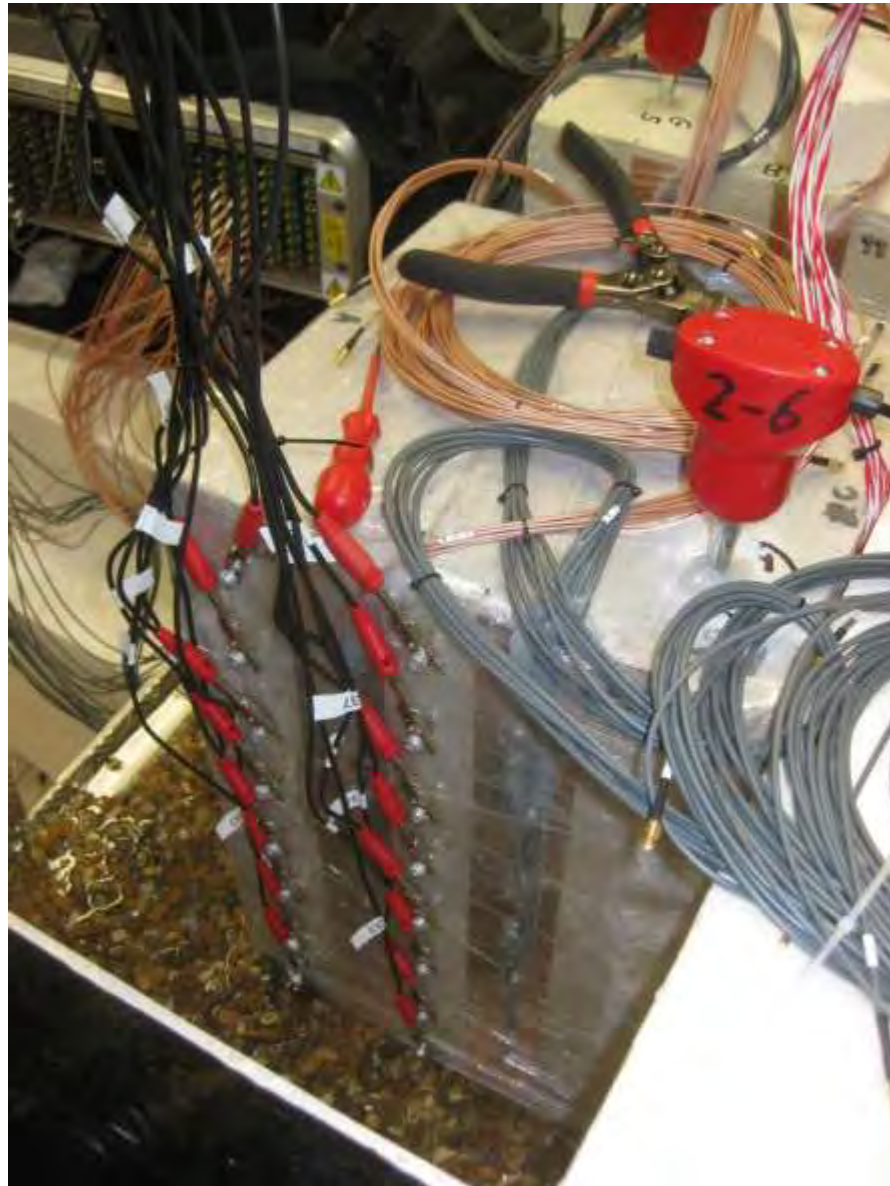
Instrumentation on each block

- 32 galvanic electrodes for ERT
- 32 copper plates for capacitive EIT
- 8 TDR sensors (rock moisture)
- 8 platinum temperature sensors
- 1 heave sensor (0.01 mm)
- 1 geophone (1000 Hz, cont. recording)

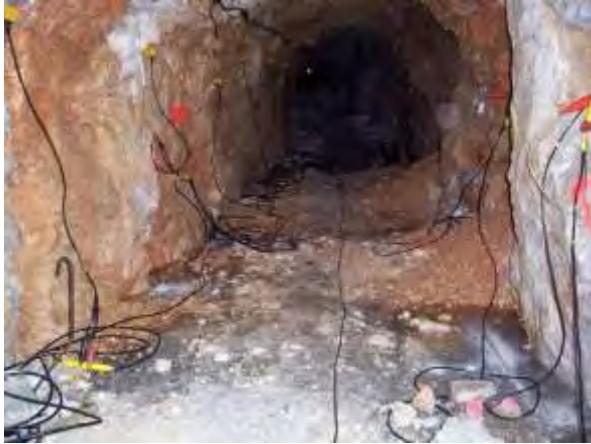
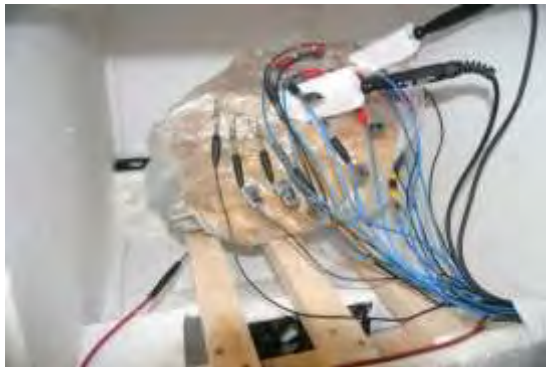
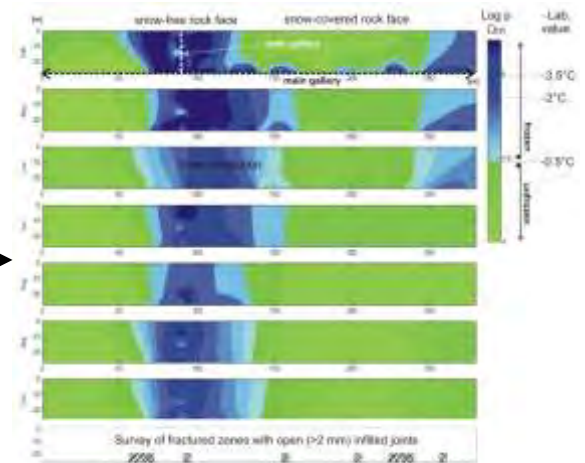
Quantitative ERT (Zugspitze, 2800 m a.s.l.)

High-res. resistivity measurement (3000 datums)

Finite element grid

Empirical error model

Laboratory calibration

Temperature-resistivity function

Temperature-calibrated ERT (Krautblatter et al. 2010 JGR)

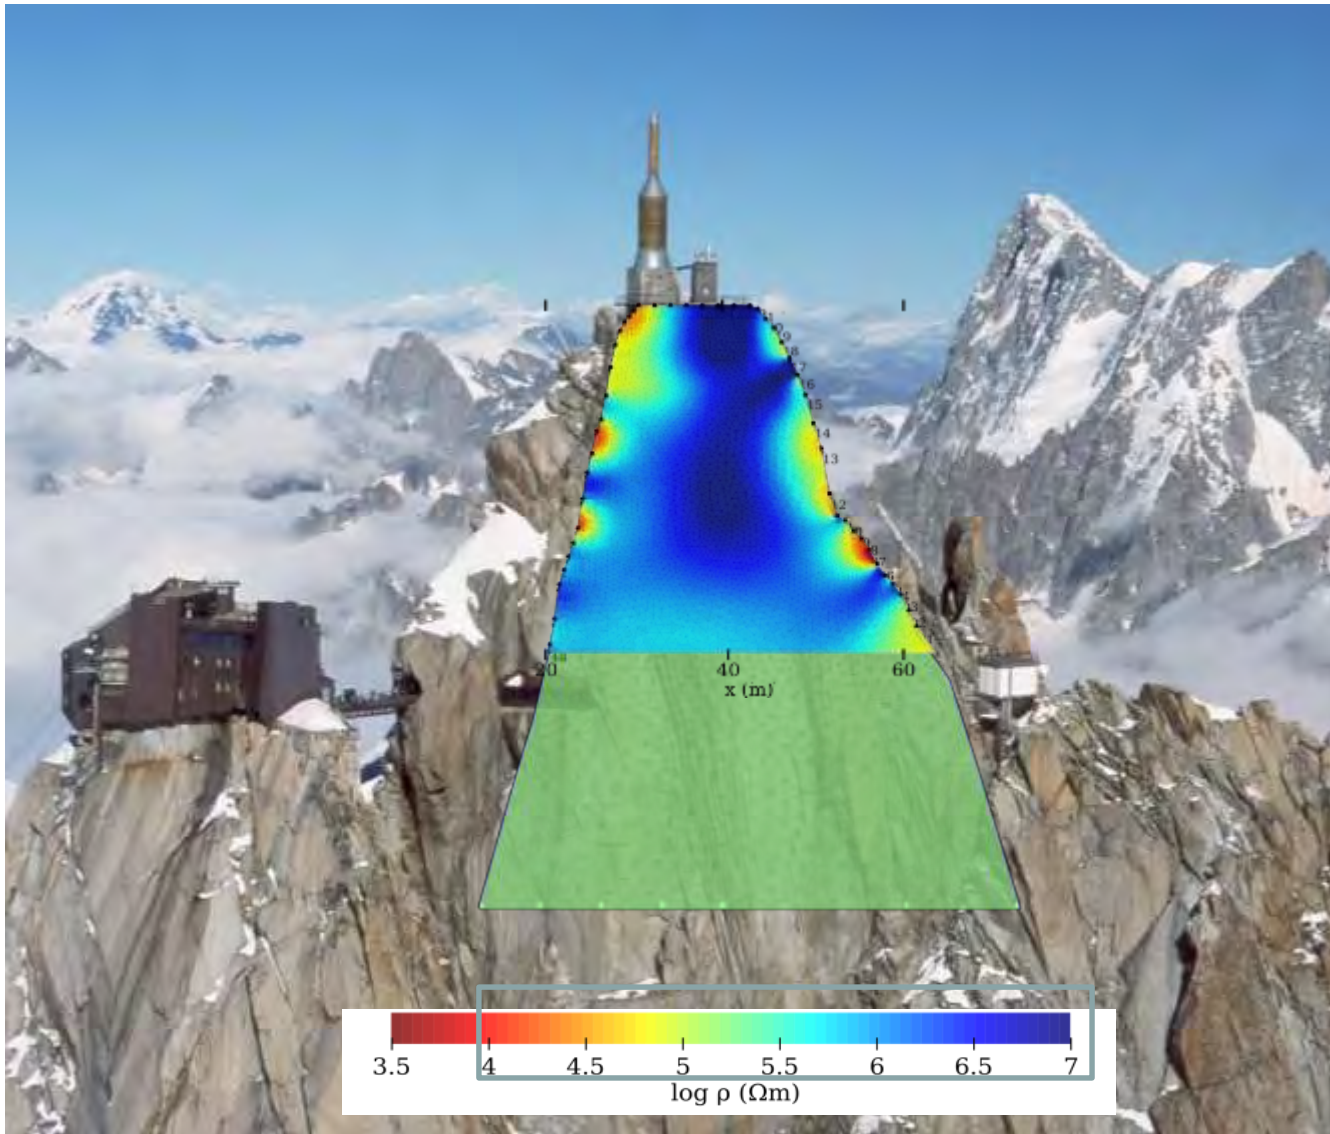
Piton Central

Altered Colour Scale!

- Skip 3
- Robust inversion
- Rel. error: 36,19 %
- Abs. error: 23,07 Ω
- Background resistivity: 10.000 Ωm
- 156 datum points

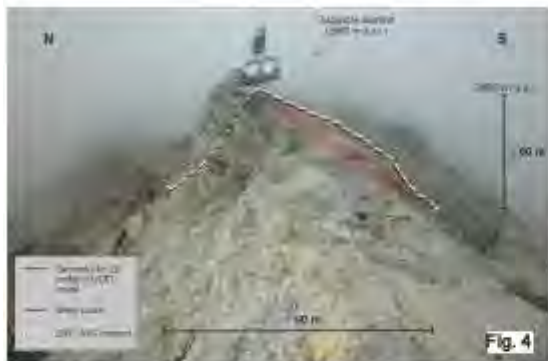
Fig. 4: Study site with profile used for modelling.

- first modelling results: higher xy-displacements and lower factor of safety for „unfrozen condition“ (fig. 5)
- next step 1: assign „frozen material parameter“ to frozen zones identified by i) geophysics (ERT, SRT) and ii) direct rock temperature monitoring (fig. 6, right)
- next step 2: calculate with complex topography and joint set configuration

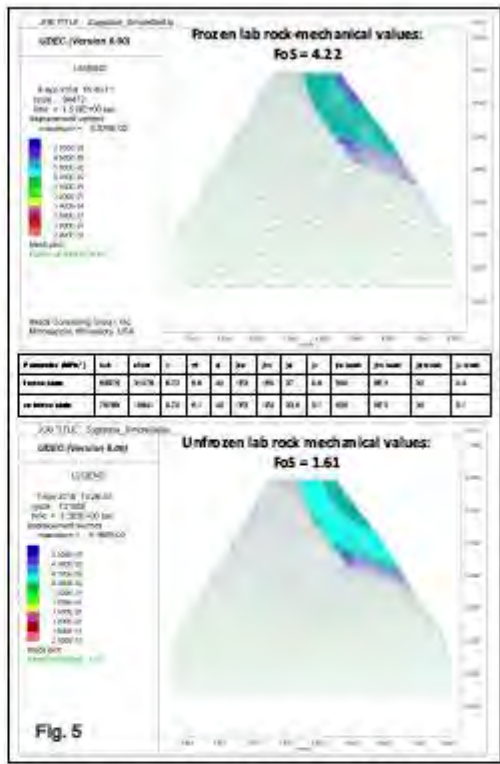
Fig. 5: Two UDEC models with simple geometry of the Zugspitze crest, displacement vectors (in meters) and calculated factors of safety for frozen (above) and unfrozen conditions (below).
